NPDES Phase II Permit Monitoring Report Biological and Bacteriological Sampling

Montgomery County Jurisdiction Assessment
Montgomery County, Tennessee

January 2019

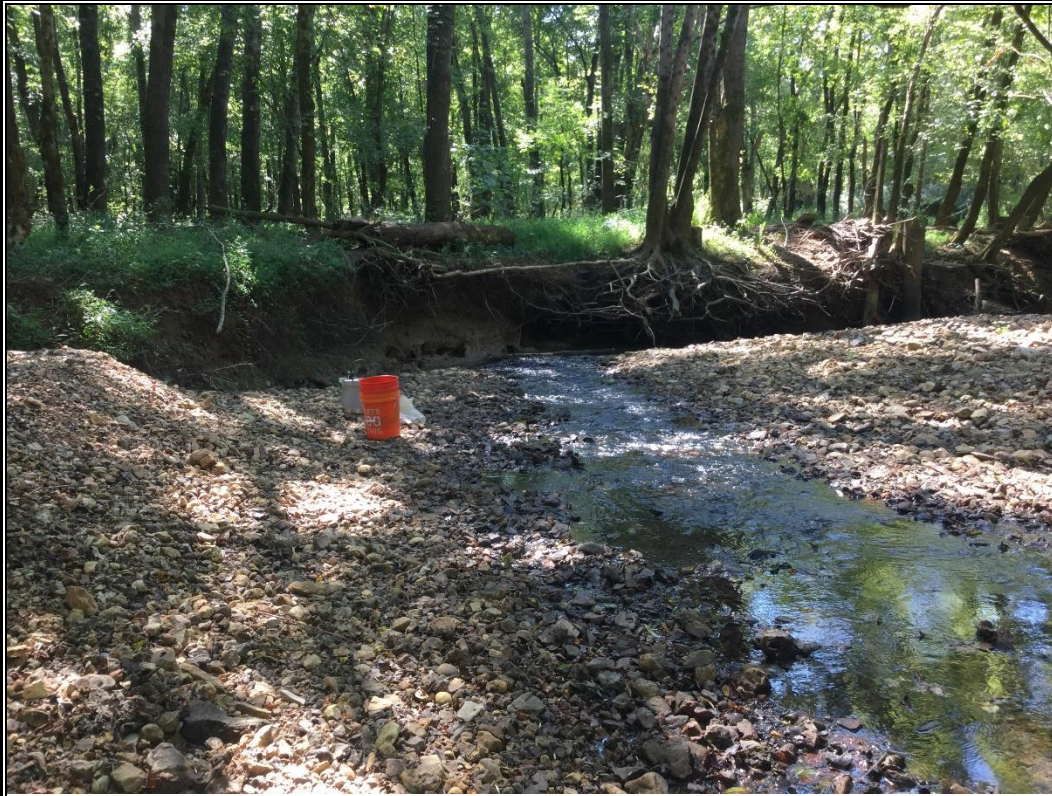
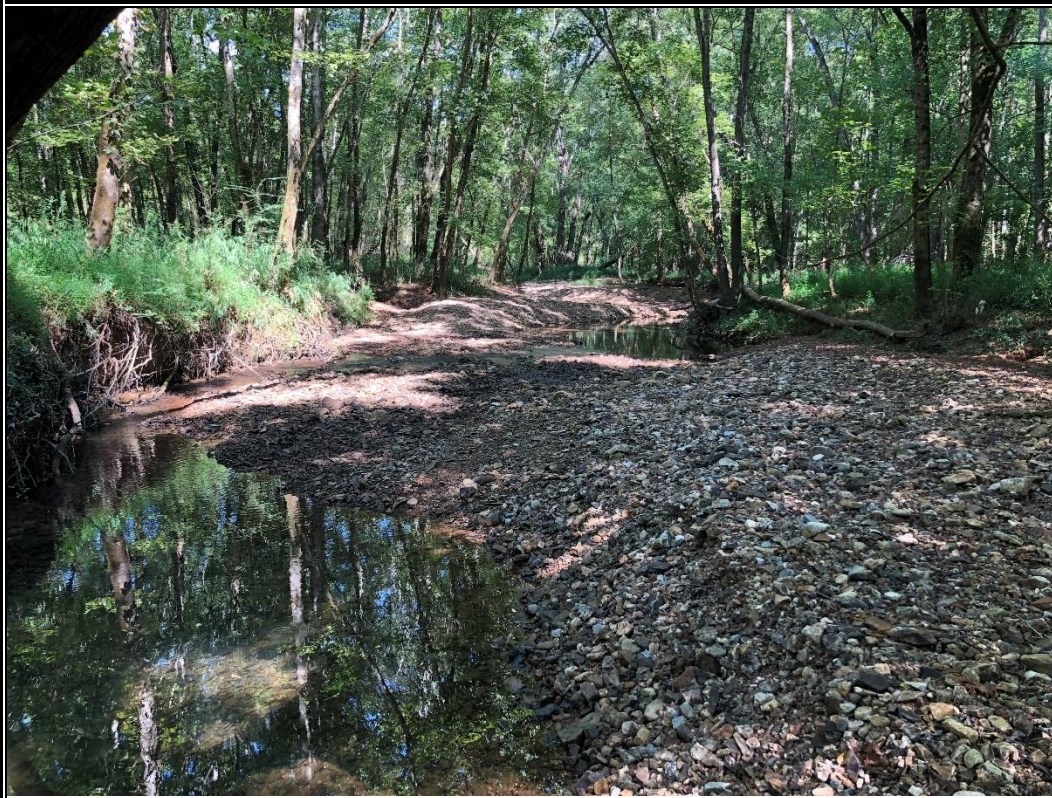
Photo: 1
By: N. Carmean
Date: 19 Sept 2018
Feature: WALL000.6MT
Photo Location:
36.4964, -87.2994

Bank stability and sediment deposition are the two limiting factors in this reach. Heavy erosion was noted on each bank throughout the reach, and because of that, there is sediment deposition along the margins and in pool areas. The riparian vegetation is well preserved at this site, the left bank has dense old growth forest that extends beyond 18 meters, and the right bank has been cleared along the outer edges near the water treatment facility. Overall, this reach scored a 140, which is well above the ecoregion reference score.

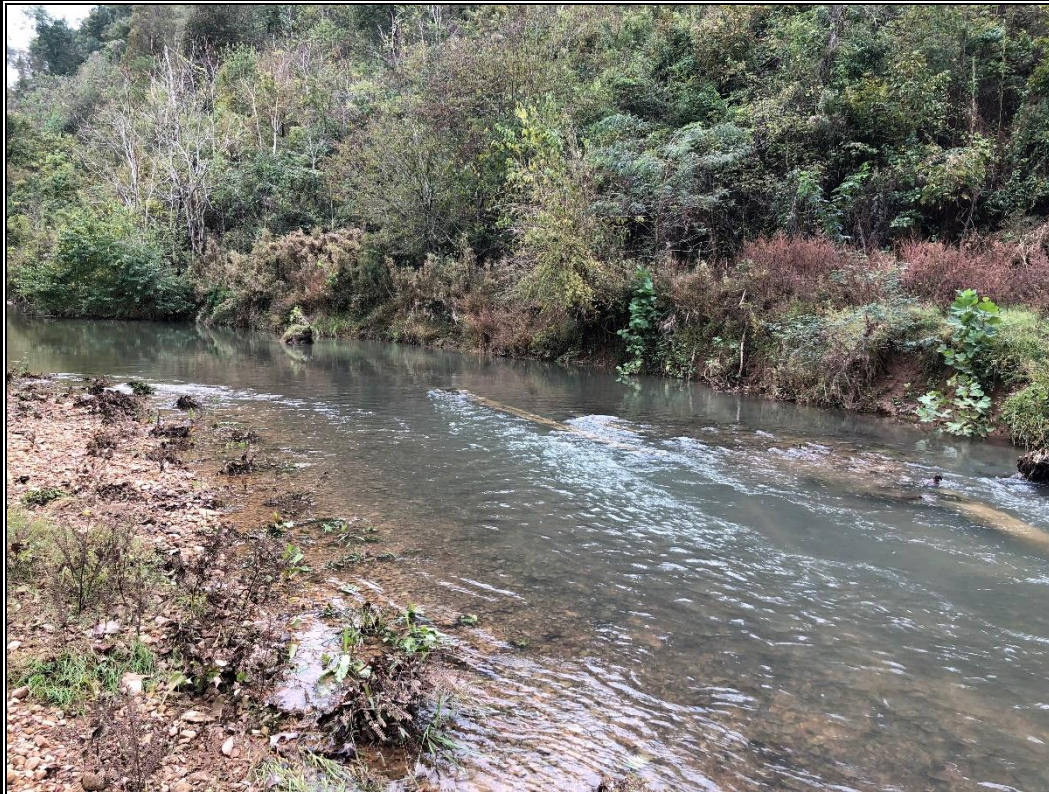
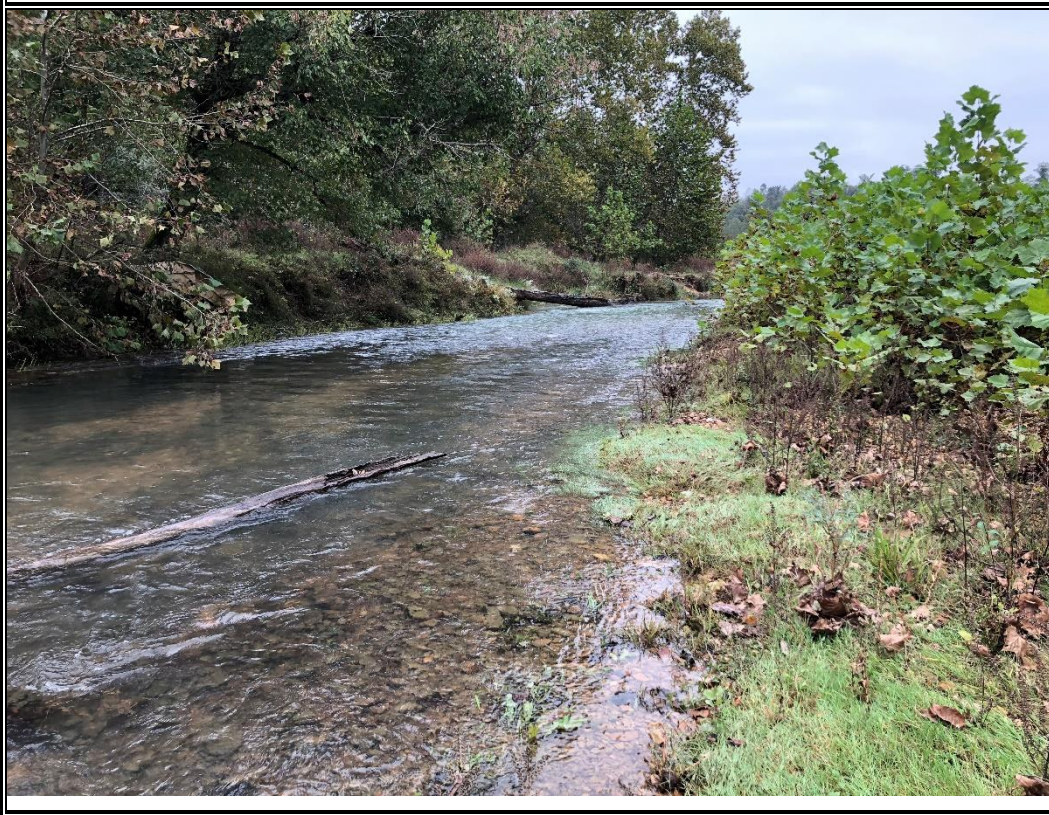
Photo: 3
By: N. Carmean
Date: 16 Oct 2018
Feature:
EFORK003.9MT
Photo Location:
36.3996, -87.5276

Upstream view East Fork Creek near macroinvertebrate sampling location during elevated flows.

Downstream view East Fork Creek near macroinvertebrate sampling location during elevated flows.

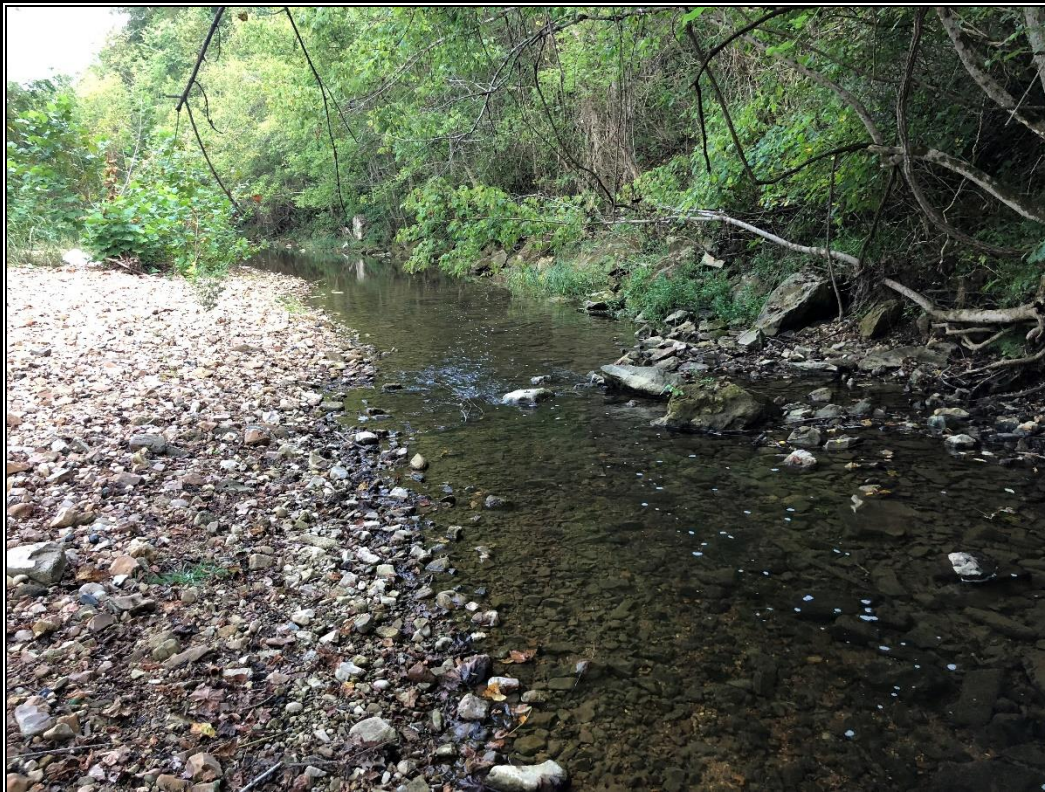
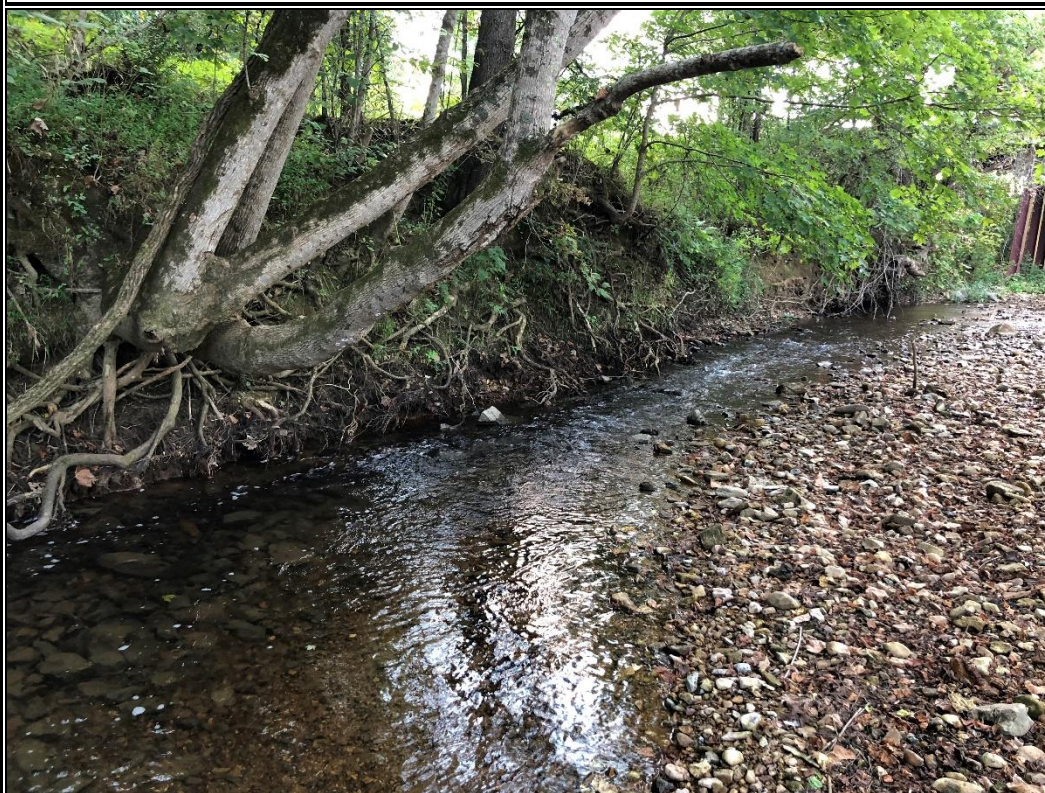
Photo: 5
By: N. Carmean
Date: 19 Sept 2018
Feature: LOUIS001.8MT
Photo Location:
36.3592, -87.3061

Little epifaunal cover was observed at this stream segment and was primarily cobble and leaf pack. In addition, there was no slow-moving deep water, and very little fast-moving deep water. Another limiting factor at this reach was the riparian zone, which primarily consisted of a fence row and then cultivated land, giving a large source of sediment deposition. This segment scored a 116, which is below the ecoregion reference score of 123.

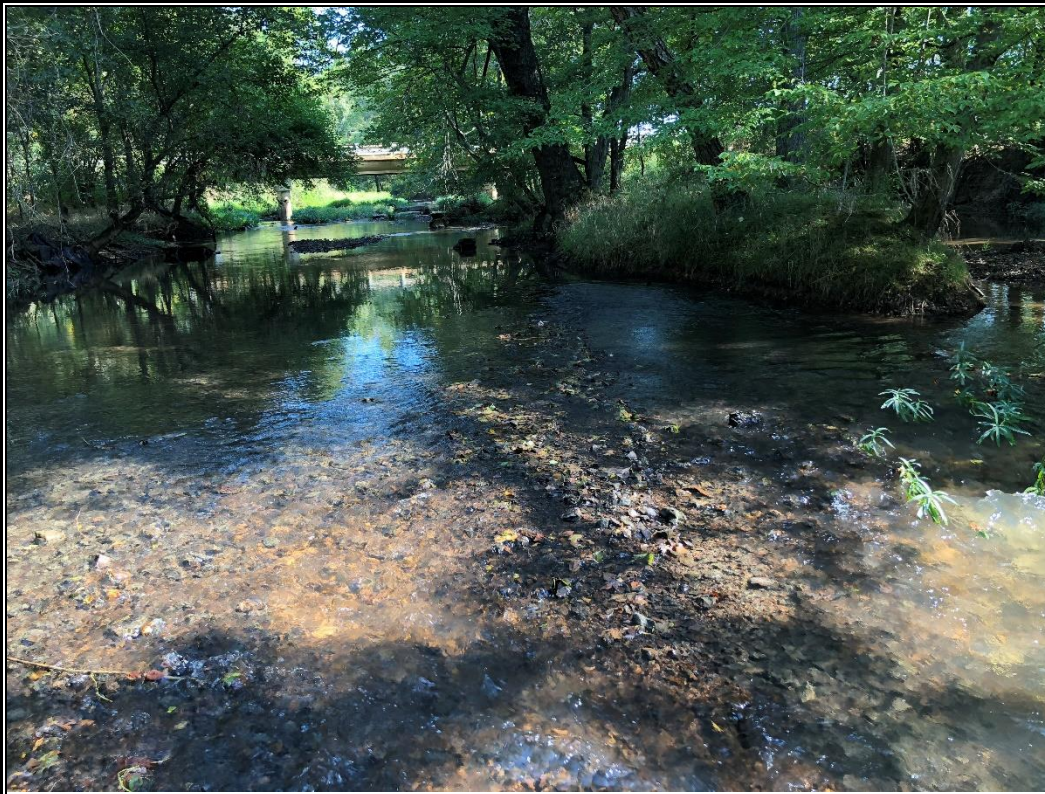
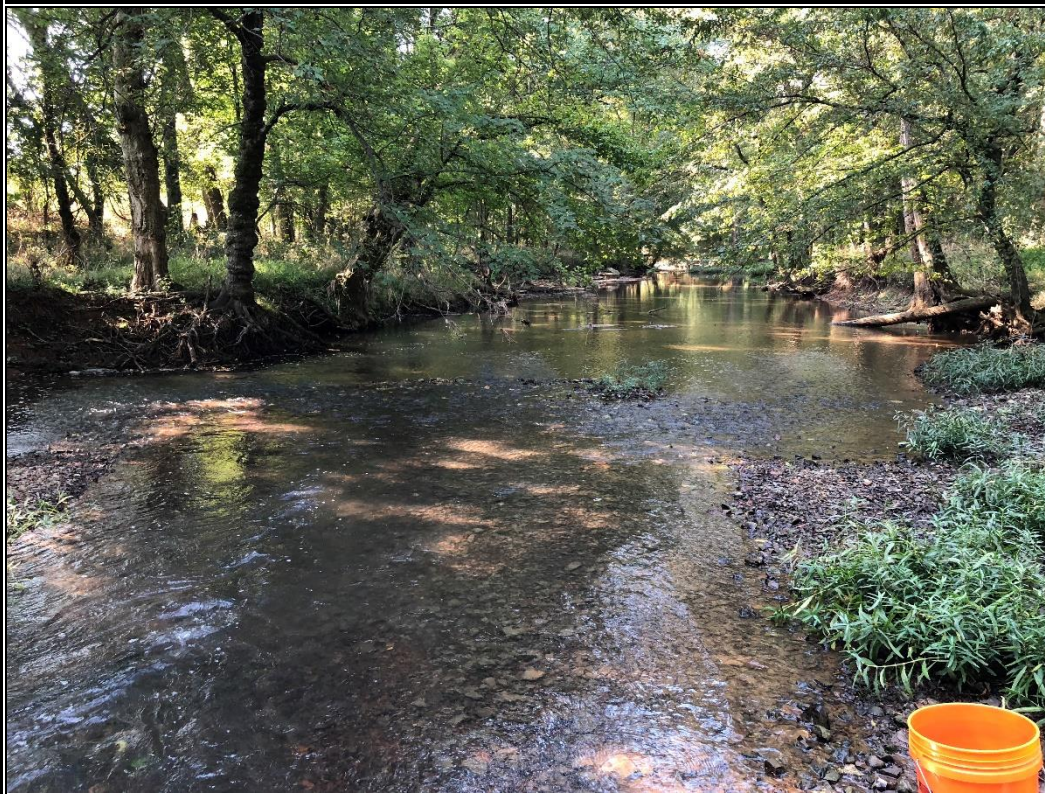
Photo: 19
By: N. Carmean
Date: 19 Sept 2018
Feature: SPRIN009.8MT
Photo Location:
36.6170, -87.2535

This stream segment was limited by the riparian zone and bank stability. The surrounding land use is primarily agriculture, with no buffer on the left bank. Erosion was evident throughout the reach and beyond as there was little vegetation to support the stability. There was, however, very little evidence of sediment deposition, especially in the riffle areas. Overall, the reach received a score of 126, which is above the ecoregion reference score.
